REPORT FOR

LaSalle Peru Oglesby
Catholic Schools
Building Assessment

Diocese of Peoria

06 September 2024

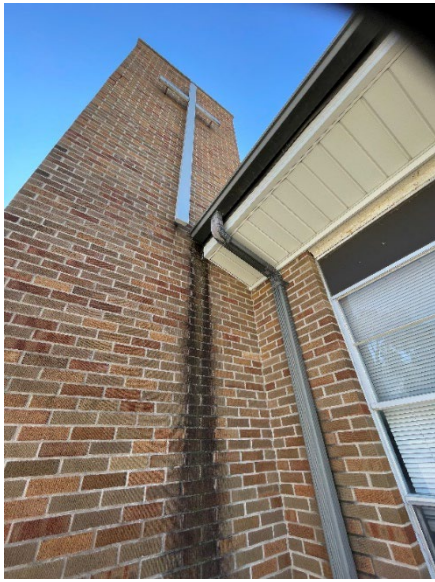
The exterior of the building appears to be in fair condition. Some water discoloration was noticed at the edges of gutters on the North and South walls of the building (see Photo #TC1). There is some minor damage to the brickwork on the exterior, though nothing considerable.

Photo #TC1 – Staining at gutter termination

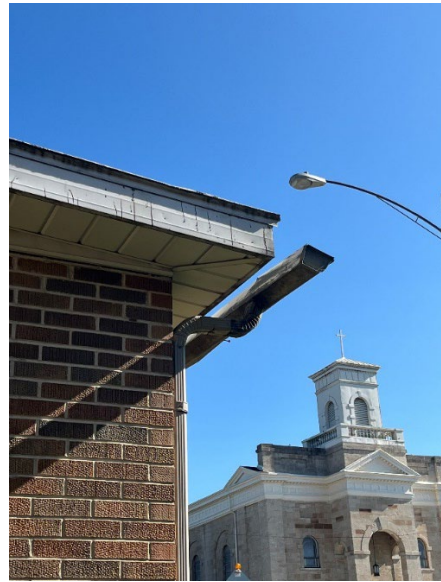
Photo #TC2 – Gutter pulled away from roof edge

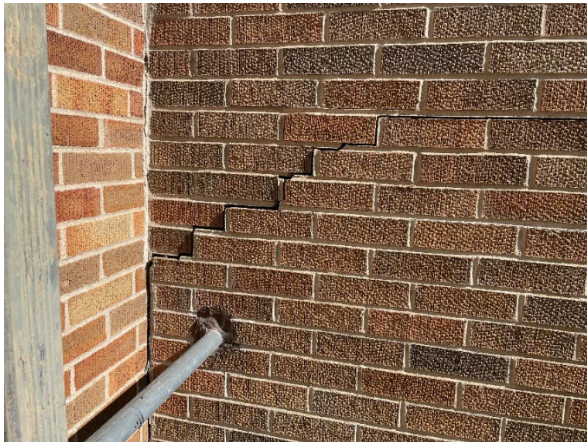
The storage addition to the east appears to be falling away from the rest of the building, with major cracks in the walls and near the connections to the existing construction (see Photos #TC3 and #TC4).

Photo #TC3 – Significant crack in the storage room wall

It is recommended that the storage addition on the east end of the building is demolished and replaced to prevent further damage to the building.

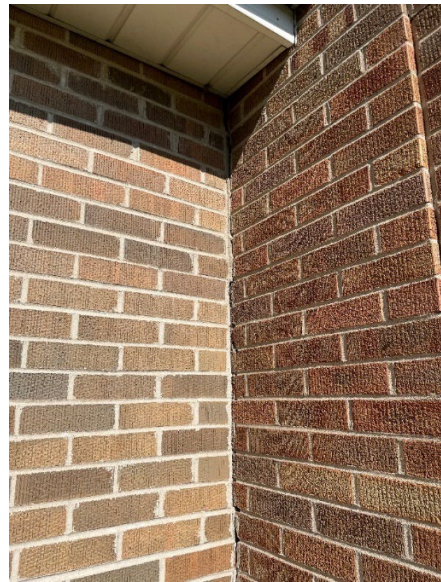
Photo #TC4 – Crack between storage addition and existing masonry

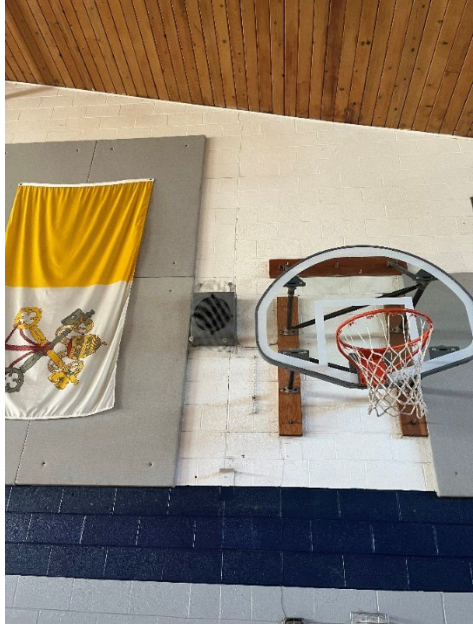
Interior cracks were observed at the windows on the west side of the gymnasium. Cracks were also observed on the north wall of the gymnasium, continuing from the lintel to the top of the wall and down to the floor (see Photo #TC5).

Photo #TC5 – Crack in gymnasium extending beyond lintel

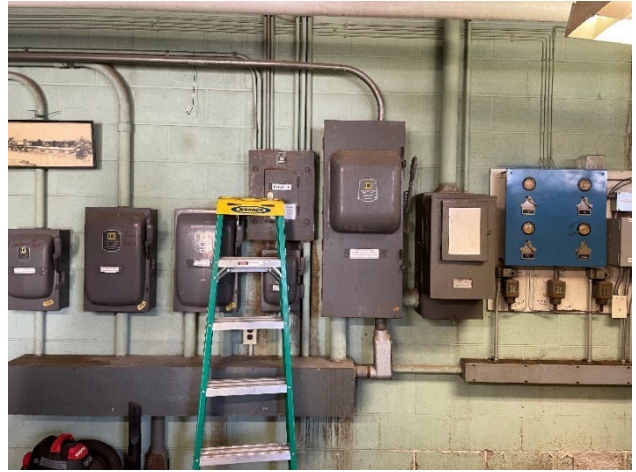
There are nine separate electrical panels in the mechanical room that appear to use the six disconnect rule for supplying power to the building (See Photo #TC6). The main panel (P1), P1A, P1B, P2B, and staff panel all have 100 amperes. P2A and the gym panel have 200 amperes, the "shutoffs" school panel has

400 amperes, and the boiler has 60 amperes. These panels would need a service upgrade to bring all the shutoffs into one load center with a capacity of at least 600 amperes.

Photo #TC6 – Distribution of electrical panels using six disconnect rule

The electrical service would need to be replaced down to the branch panels, as the six disconnect rule can cause significant issues in the long term. The new load center for the building would need to support at least 600 amperes, although 800 amperes may be required. The original hydraulic boiler is well past its life expectancy and replacement with a modern system should be scheduled if the building is planned for long term use. There is also asbestos located in the mechanical room that, if disturbed, would need to be abated.

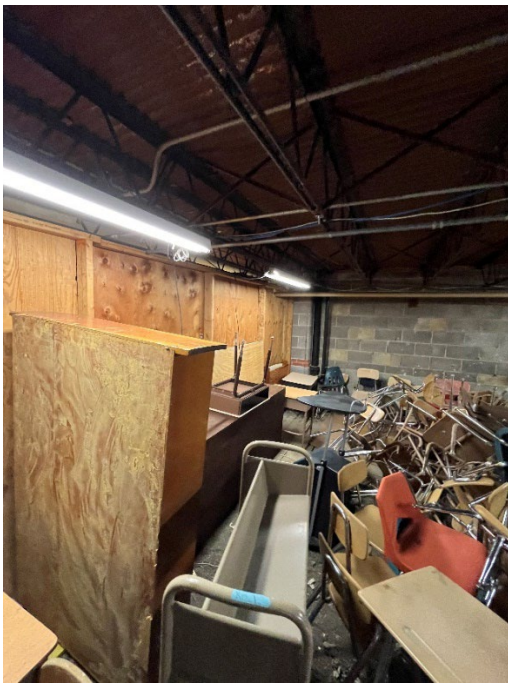
There is a large, unfinished basement beneath a significant portion of the school that is used for storage space. This space is not fire rated or sprinklered and is inconsistent with the original building codes. To bring this up to code, the storage space will need to be cleared out and treated.

The building contains a storage room in the excavated crawlspace of the building that has been outfitted with wooden partitions and floor systems and is open to the unprotected floor structure above (see Photo #TC7). This use is inconsistent with the original 1955 building and fire codes, and we recommend that this be addressed without delay. Fire code requires one hour of fire separation between Storage and Education occupancies. The steel joists that make up the structure would need to be protected with at least an hour of fire separation. If the contents need to be kept it would be best to find storage space elsewhere.

Photo #TC7 – Basement storage room

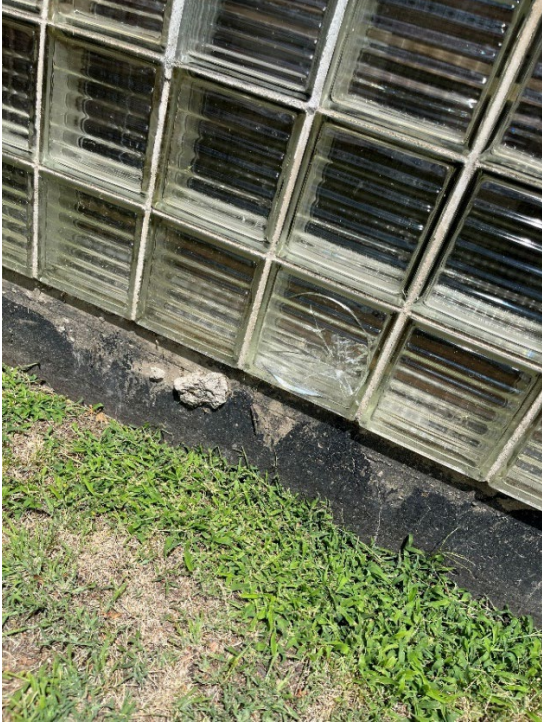
The existing condition of the building appears to be in fair to good condition, but it is not without some problems consistent with buildings of this age. There are some minor cracks around the corners near the foundation, but nothing significant. One of the glass blocks near the entrance is shattered (see Photo #PC1).

Photo - #PC1 – Fractured Glass Block Unit near Entrance

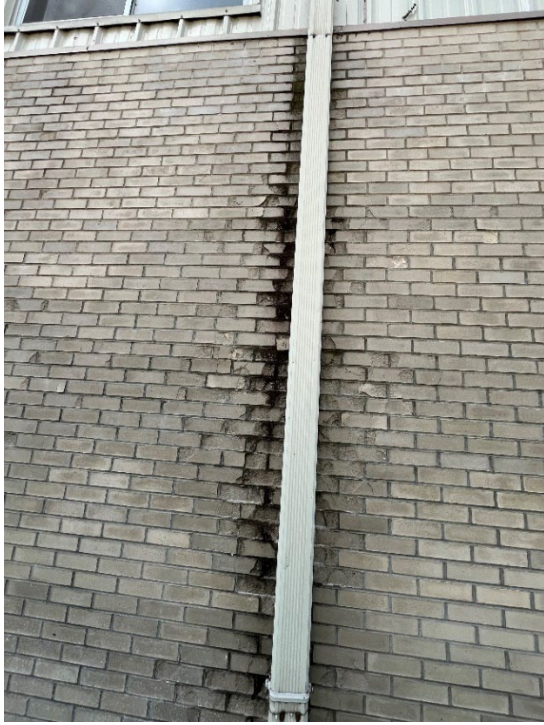
The brick masonry at the gymnasium exhibits considerable spalling, especially concentrated around downspouts (see Photos #PC2 and #PC3). Spalling is the flaking off of the brick face, often due to a combination of water and the action of freezing and thawing cycles. This condition will continue to get worse unless changes are made to the amount of water on the brick. In the main building, there are active leaks in several window openings (i.e., Kindergarten, Classroom 004, Boys' Toilet, etc.) that are allowing water penetration.

Photo #PC2 – Spalling behind downspout on gymnasium addition

The addition is not a major consideration for this review, although we recommend taking action to prevent further deterioration of the masonry. Significant alterations could be made to the exterior—the roof could be replaced to have a larger overhang to keep more water off the brickwork, or metal panels could be installed over the brickwork to keep the spalling from getting worse. Further waterproofing and tuckpointing would also be recommended.

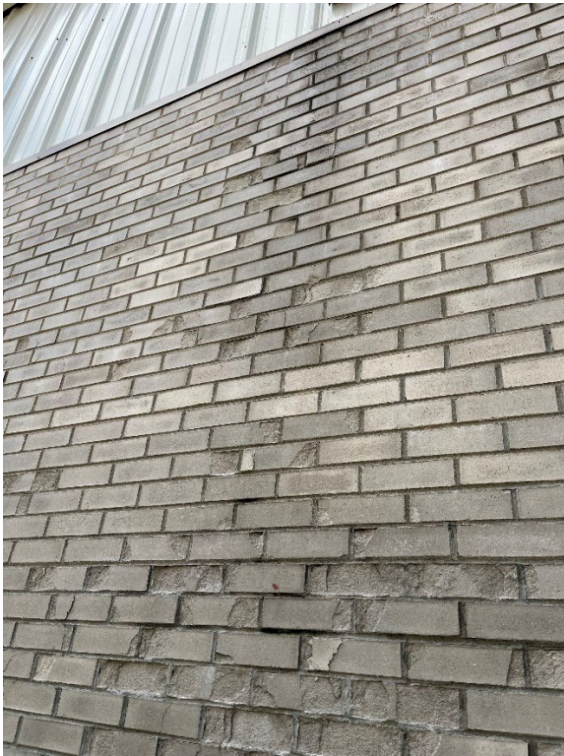
Photo #PC3 – Spalling on north wall of gymnasium addition

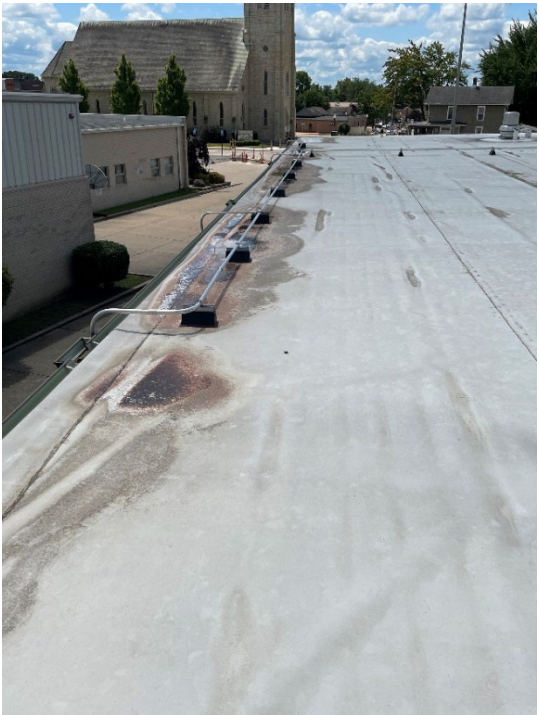
A new roof was installed in 2016, though it is in worse condition than expected for a roof of its age. Issues such as inconsistent slopes, indentations through the membrane, and ponding near the roof edges before reaching the gutters suggest that the tapered insulation was installed poorly (see Photos #PC4 and #PC5).

Photo #PC4 – Ponding near edge of roof

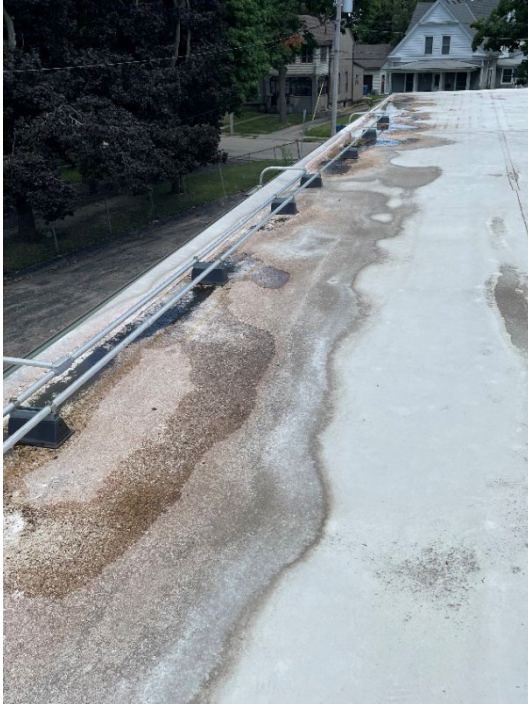
Photo #PC5 – Additional ponding near edge of roof

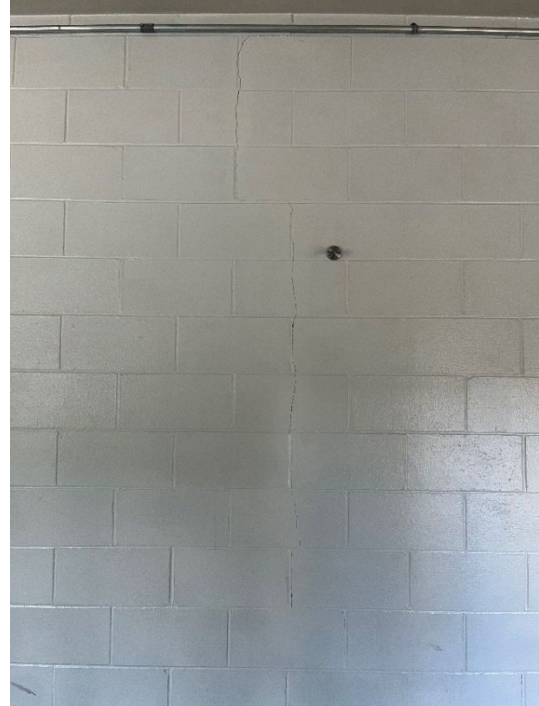
The hallway connecting the main building to the Gymnasium and cafeteria exhibited cracks in the walls at every corner and masonry opening in the hallway (see Photo #PC6). This is unusual considering the age of the building.

Photo - #PC6 – Crack in Corridor to Gym Addition

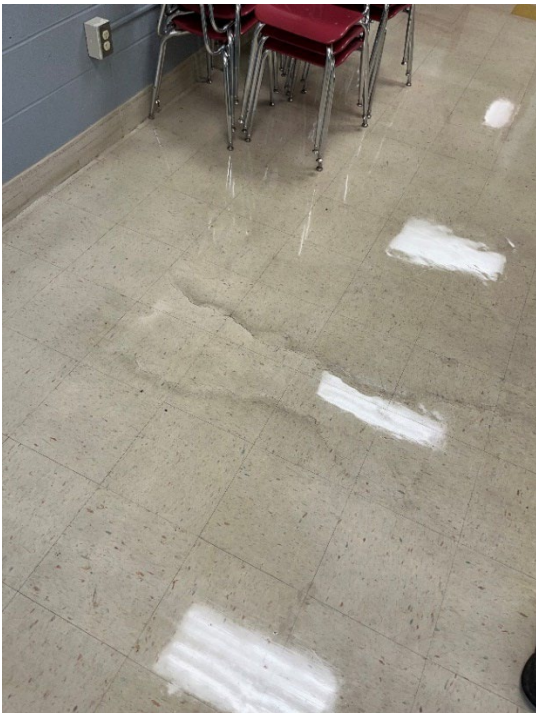
There is also some disturbance in the floor in the lower level, likely caused by the radiant heating underneath the floor (see Photo #PC7). The cover plates at the entrance support column bases have cracked and separated (see Photo #PC8).

Photo - #PC7 – Heaved Floor Slab at Lower Level

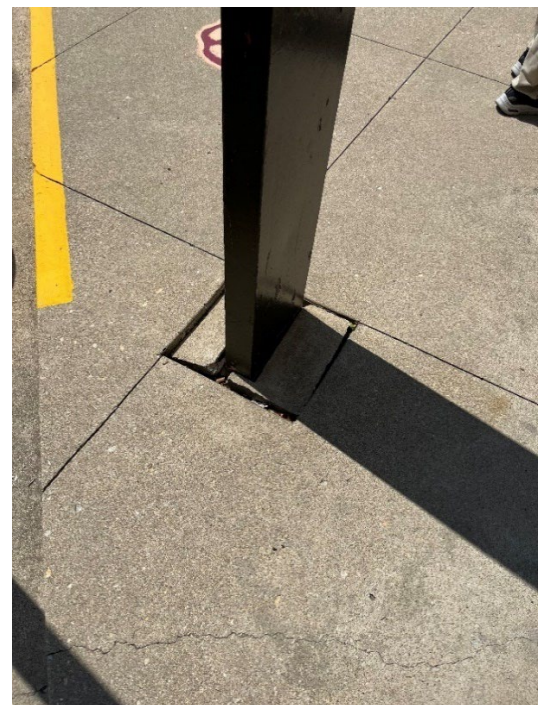
Photo - #PC8 – Cover Plate Cracked & Heaved at Entrance

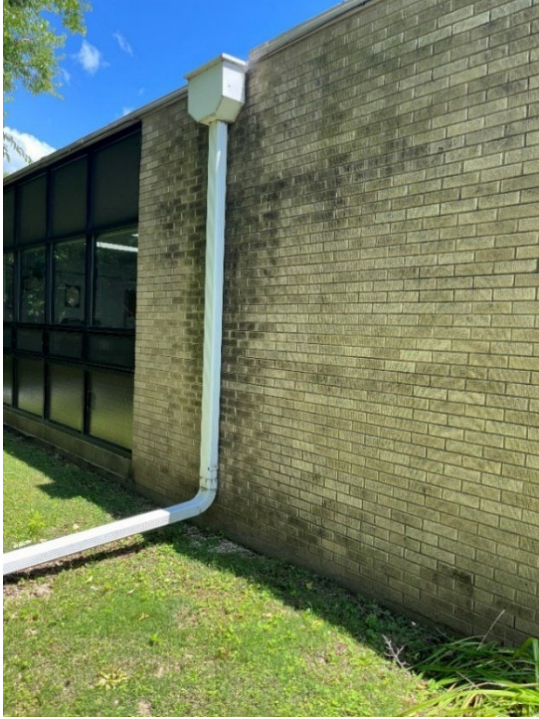
The building appears to be in fair condition. Some water discoloration was observed on the north and east sides of the building, focused on the downspouts (see Photo #HF1). There is also evidence of some repaired brickwork on the envelope (see Photo #HF2). The current gymnasium flooring was installed in 2011 and is in fair condition. The lab addition was constructed in 2008 and the vinyl siding for the addition is in very good condition. The roof was repaired in 2019 and appears to be in good condition, although some plant growth was observed on the roof (see photo #HF3). The windows in the envelope are in good condition with hopper style operable windows. Skylights located in the gym and classrooms act as an amenity for natural daylighting.

Photo #HF1 – Staining and potential infiltration at conductor & downspout.

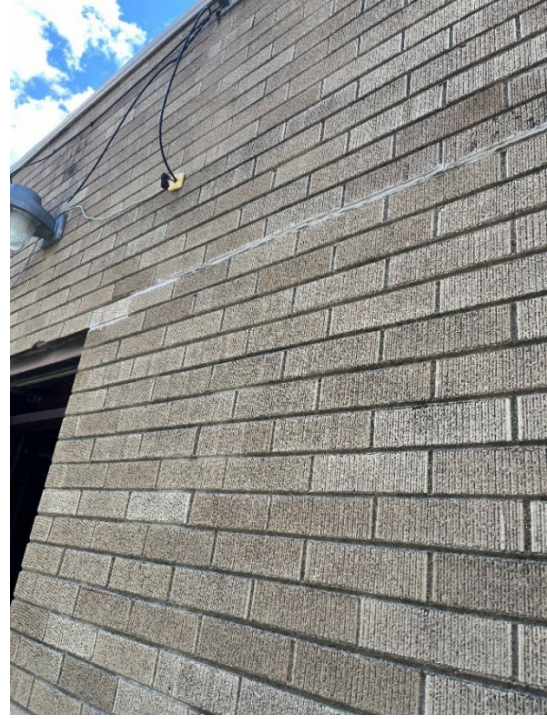
Photo #HF2 – Horizontal crack in brick veneer

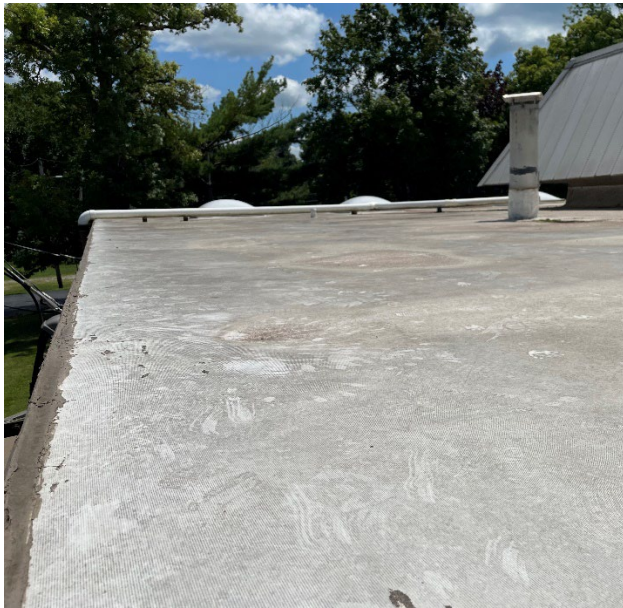
Photo #HF3 – Evidence of ponding on low roof

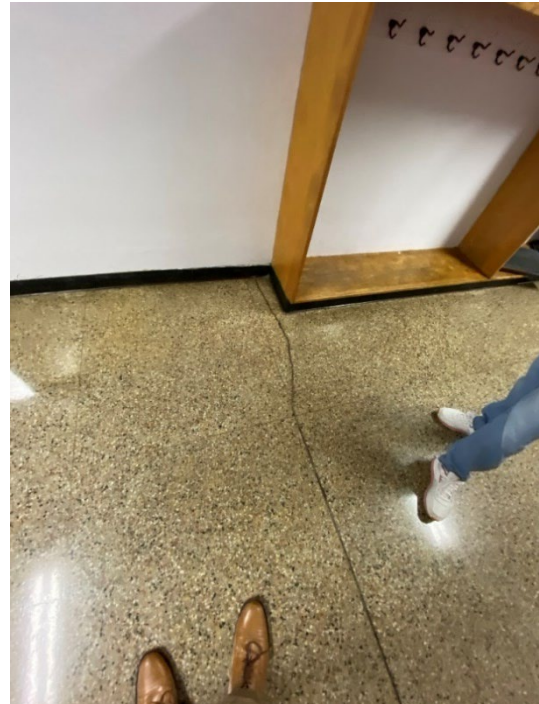
Minor settling cracking was observed on the envelope, with little indication of separation of exposed CMU bearing walls. A crack through the flooring and slab on the east side of the main lobby was observed with little or no vertical displacement (Photo #HF4).

Photo #HF4 – Floor crack

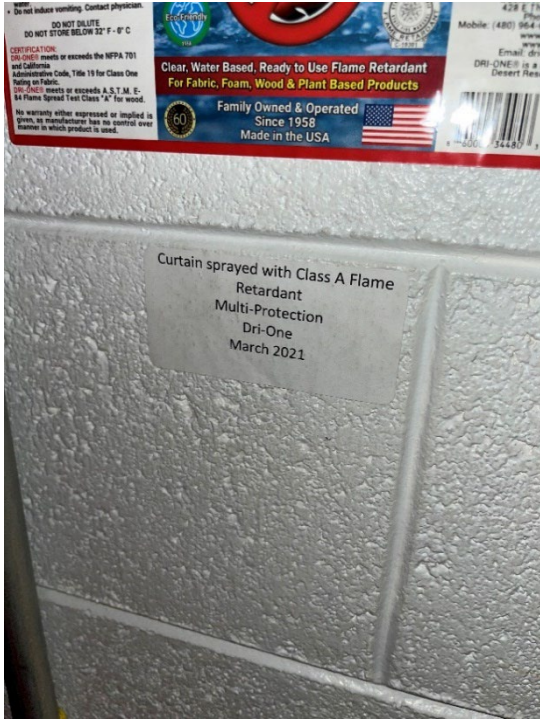
The building's square footage is within the limits for a construction type IVB non-sprinklered building with an educational occupancy. However, because there is fire separation between the gymnasium and the other classrooms, it may need to be classified as an assembly space. The building's square footage is still within the limits for a construction type IVB non-sprinklered building with an assembly occupancy, but there is less allowance than the educational occupancy. The gymnasium has a sufficient number of exits. The building is unsprinklered and there were no documented fire rated doors. The stage curtains are treated with Class A fire retardant (see Photo #HF5).

Photo #HF5– Stage curtain treatment

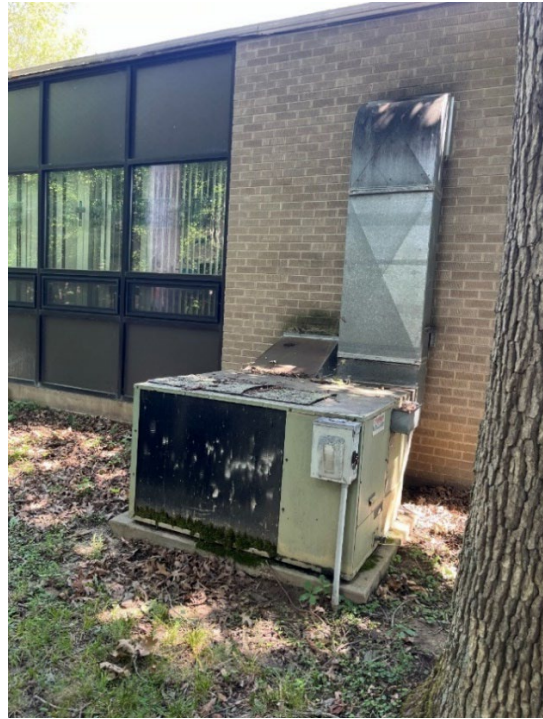
Photo #HF6– Weathered AHU (northwest)

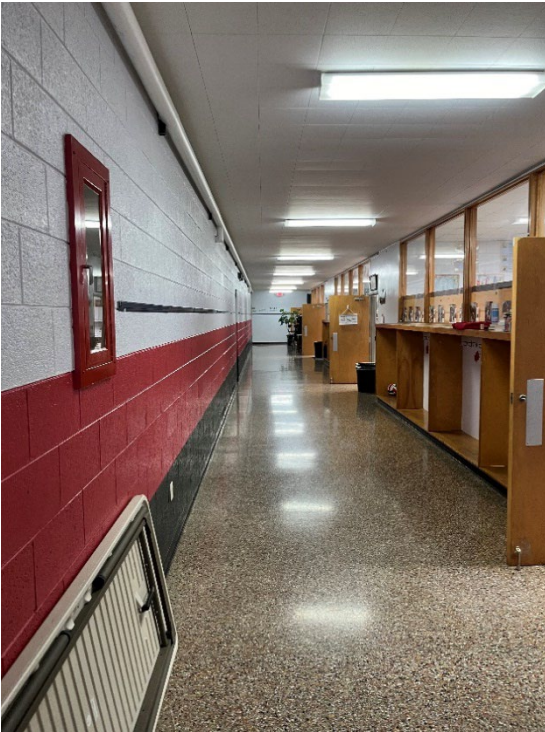
Photo #HF7 – Non-rated corridor condition

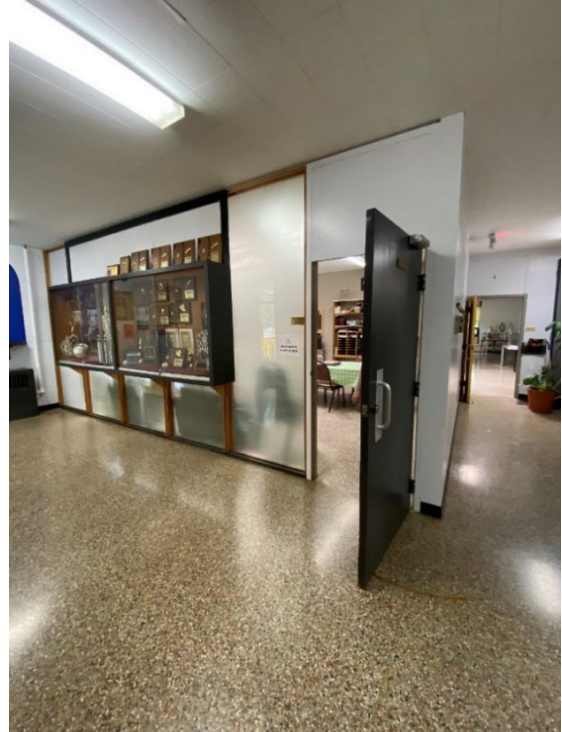
Photo #HF8 – Non-rated corridor condition

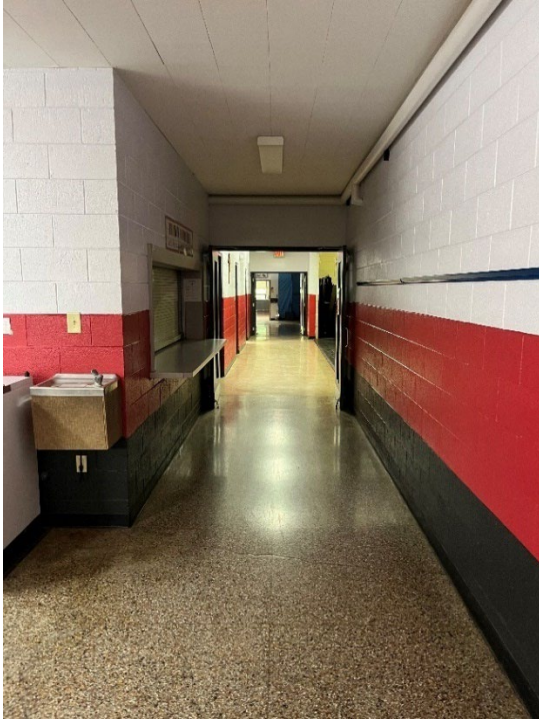
Photos – #HF9– Protruding counter

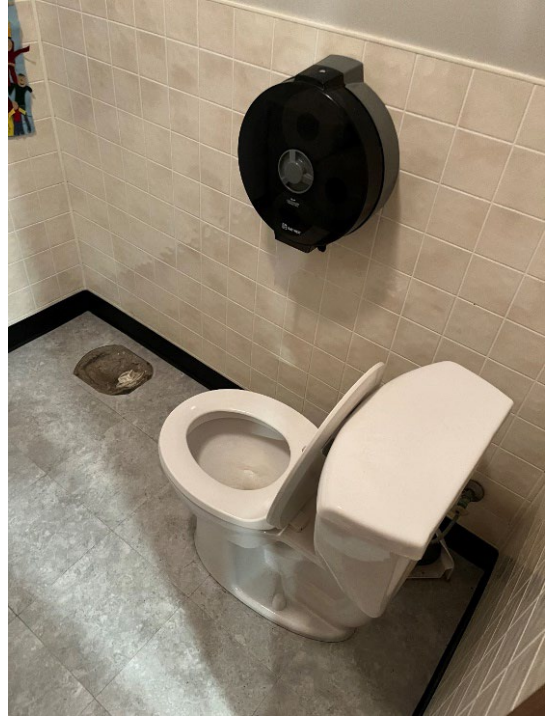
Photos – #HF10– Uncovered opening and toilet location
